## Hydrologic Workshop USGS Kentucky District

## Rapid Stream Assessment Urban Stream Restoration

Don Roseboom and Tim Straub,

USGS, Illinois District

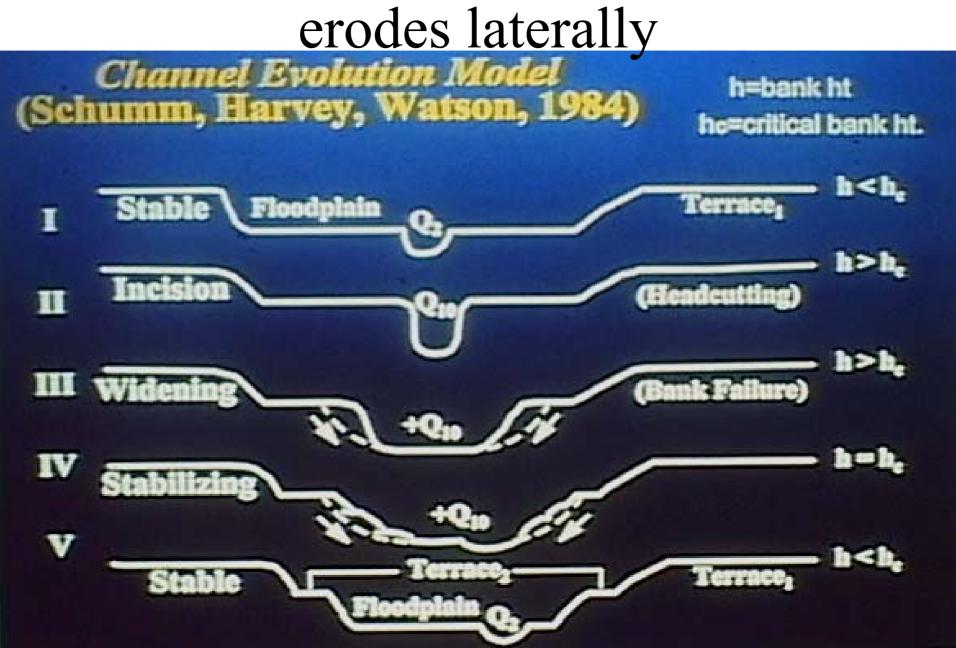
Streambed erodes down and then erodes laterally

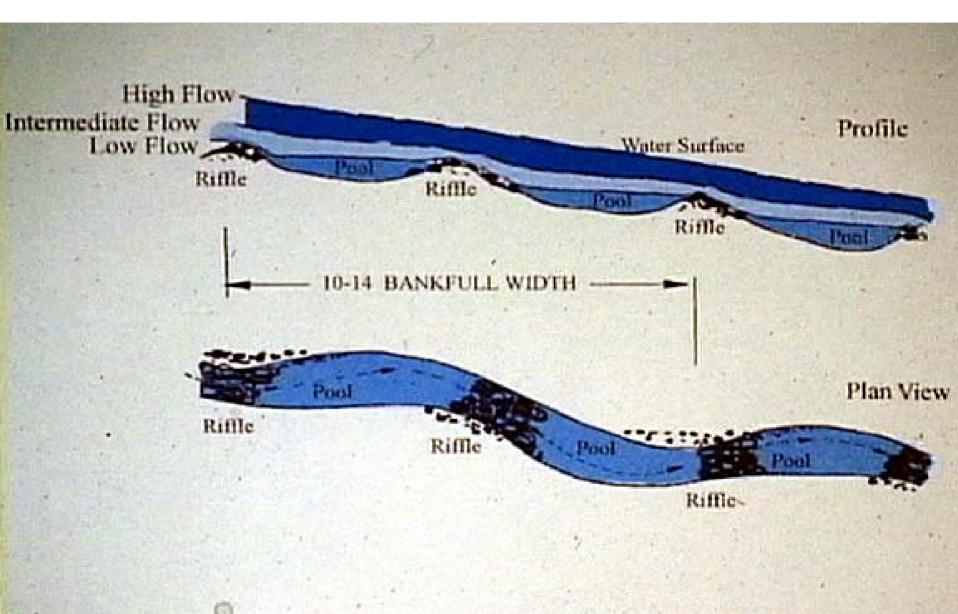
# Newbury Riffles (weirs, rock grade controls) in straight channelized streams

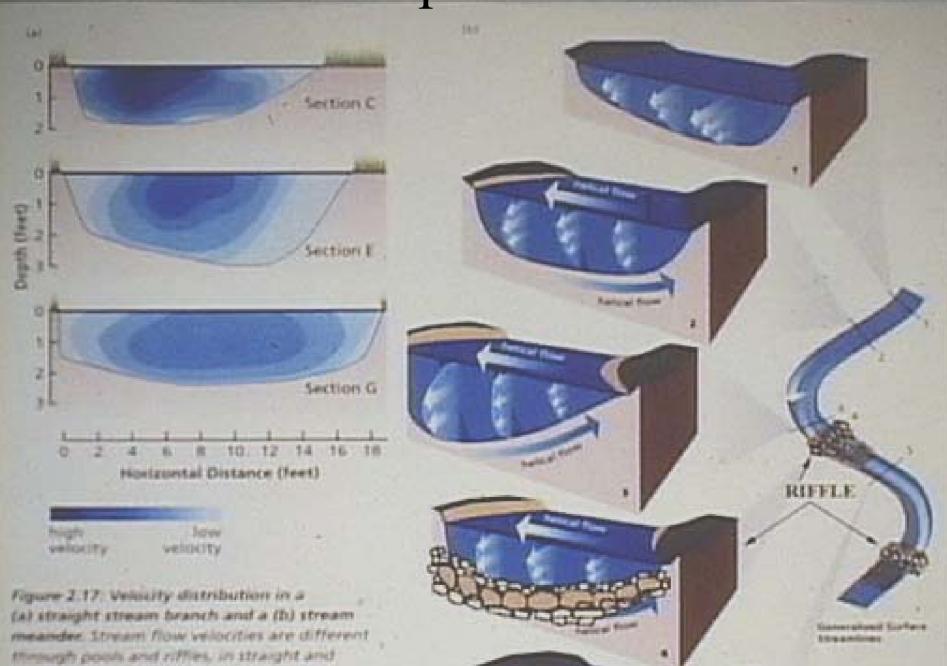
Weirs breakup meander vectors

### Weirs placed in meander exits

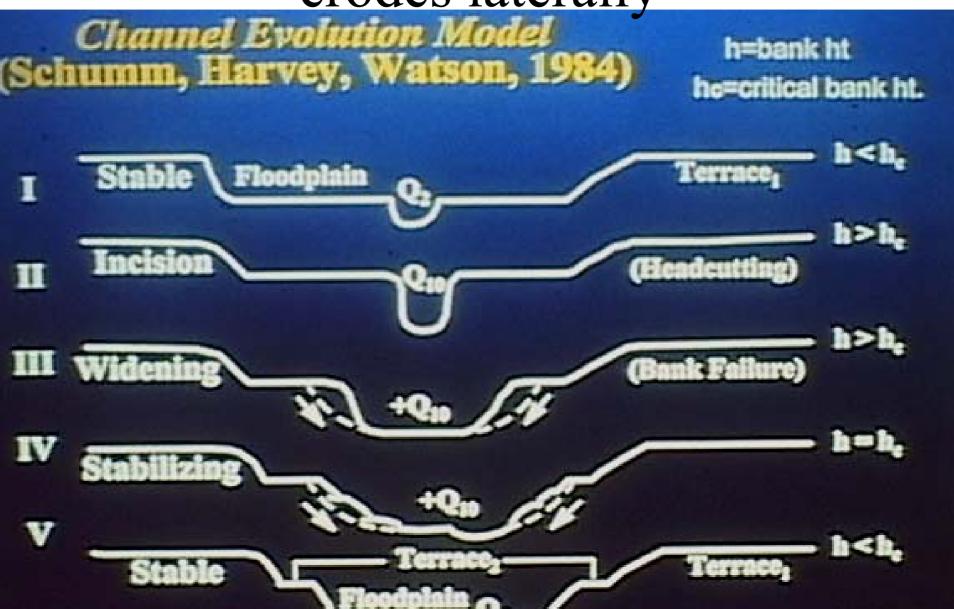
Streambed erodes down and then erodes laterally

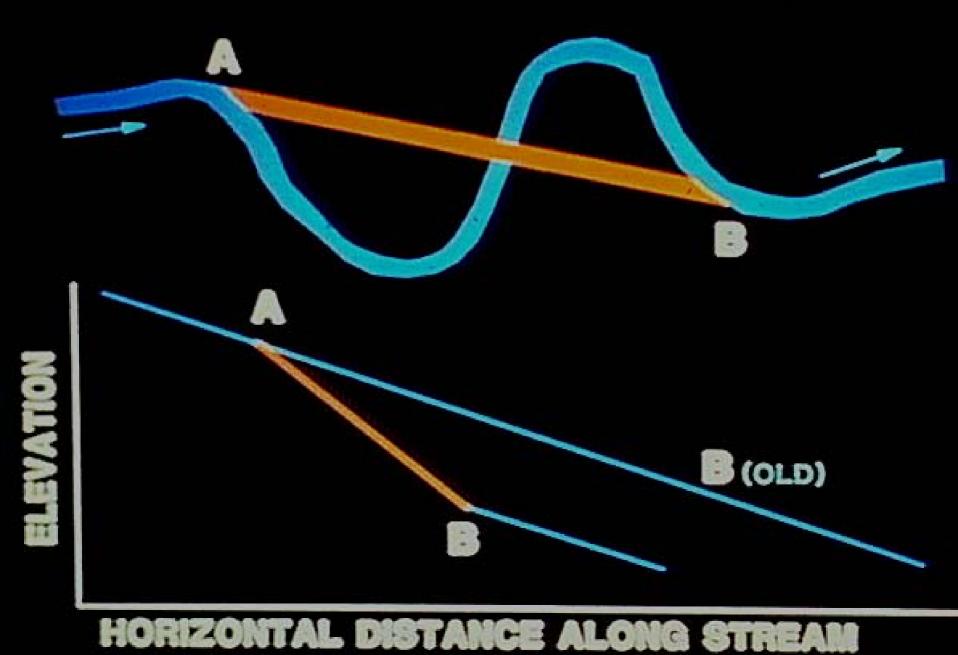
#### Channelization effect on slope

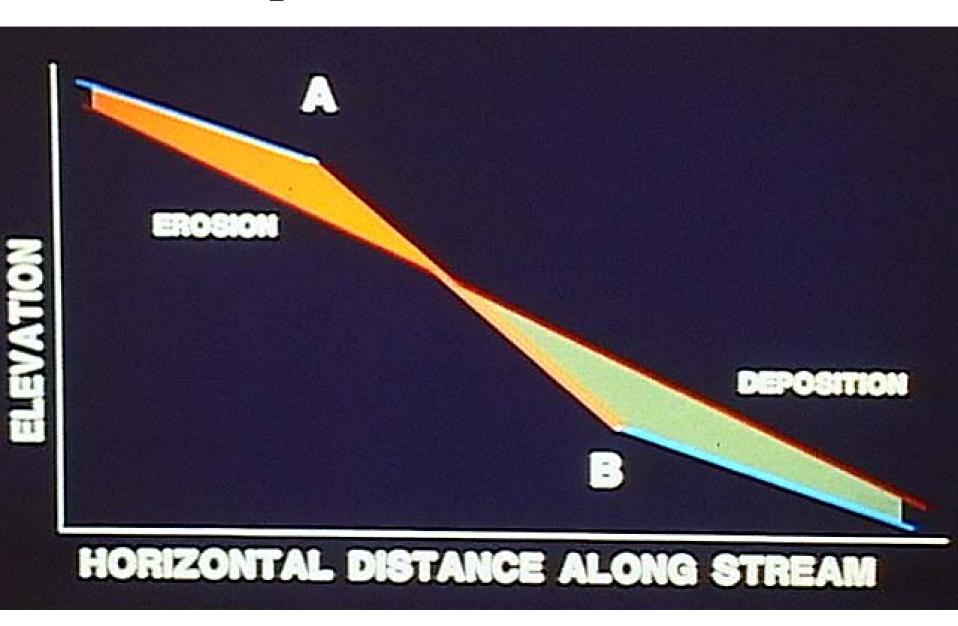
#### Slope effect on erosion

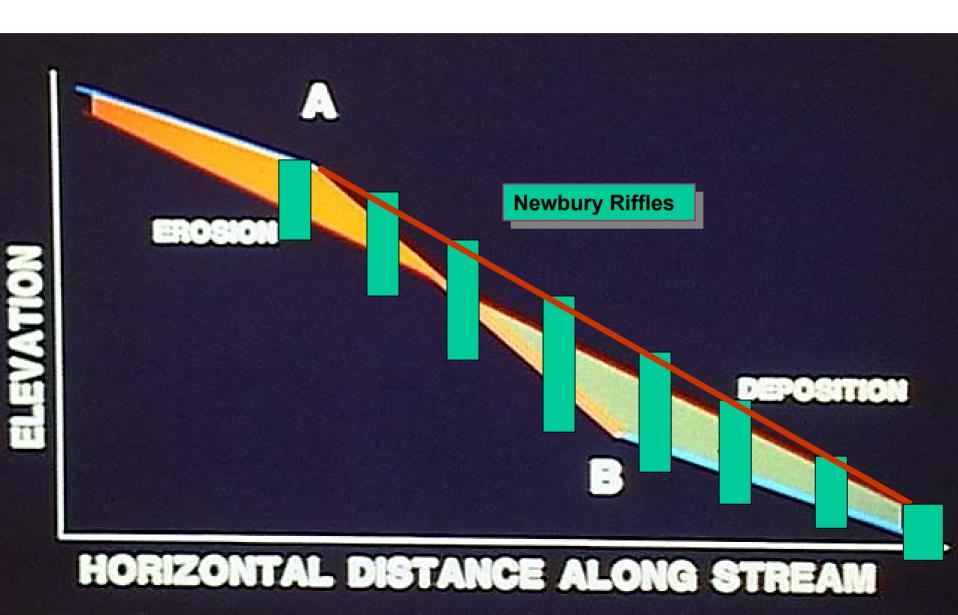
Weirs spaced about 300 ft apart. Total length of one weir about 75 ft.

#### Newbury Riffle effect on slope

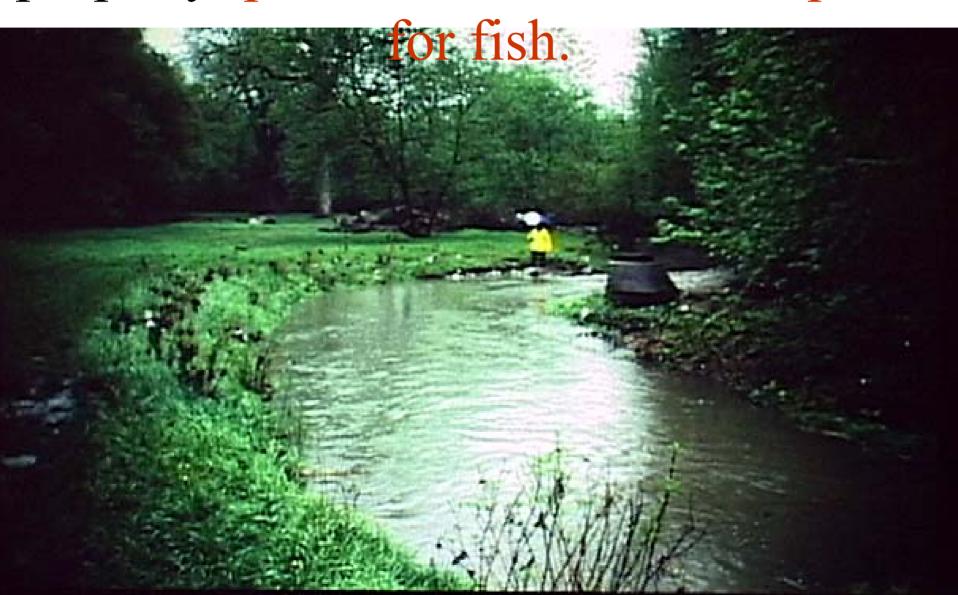
While bank stabilization protected property, pool and riffles were required

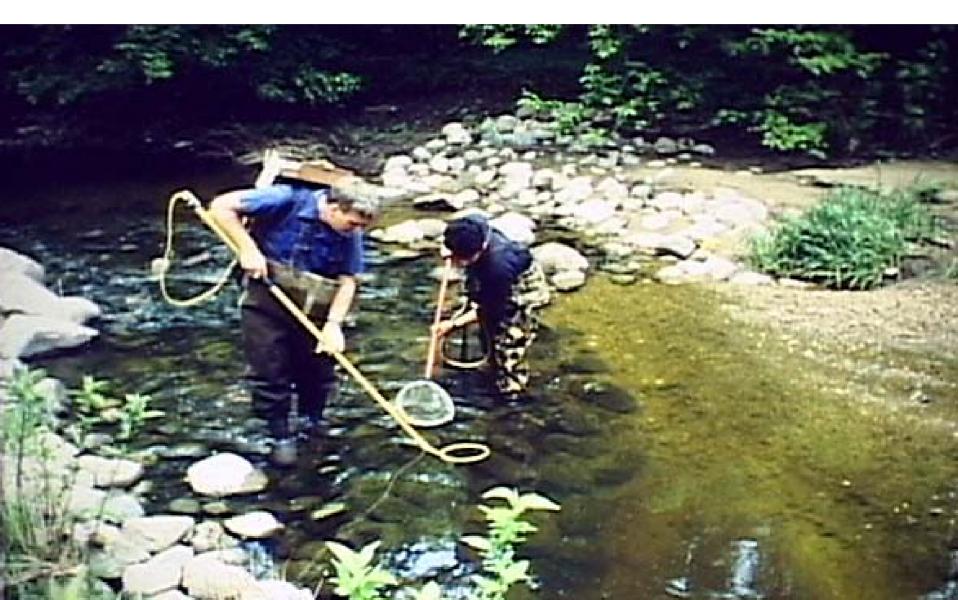
## Most pollution intolerant species were found in swift rock riffles

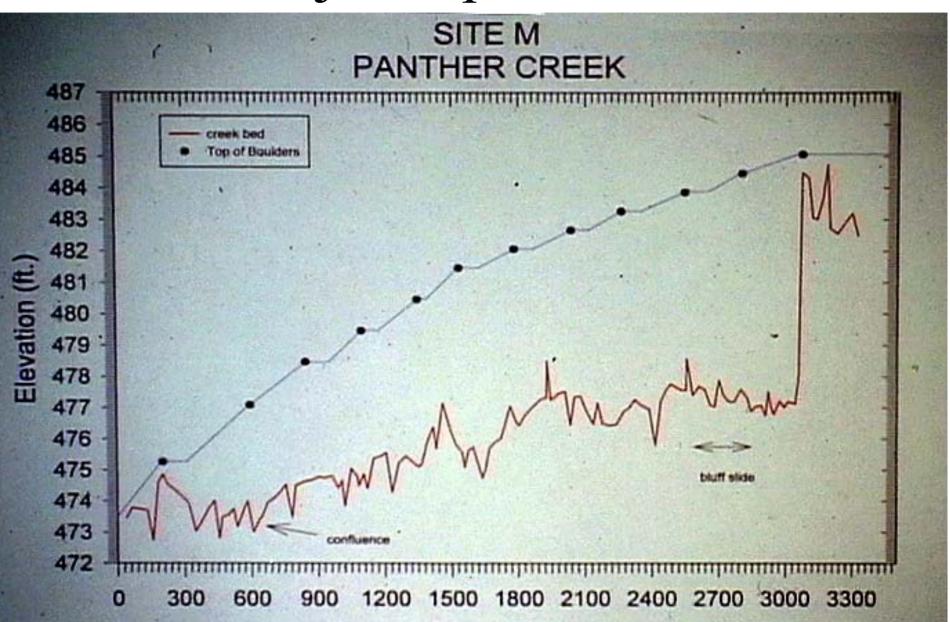
## Headcut just upstream of bluff

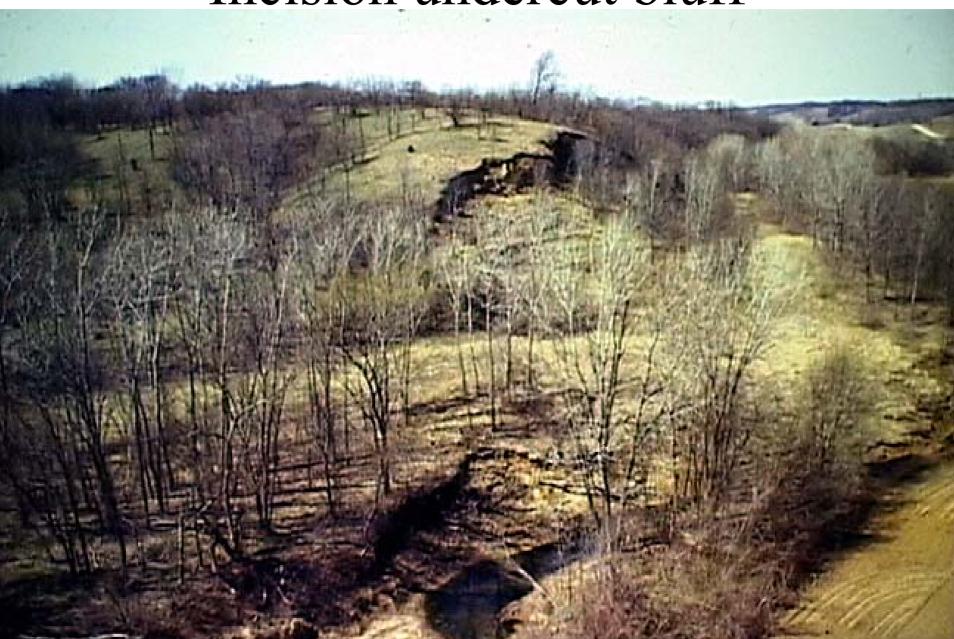
## Incision undercut bluff

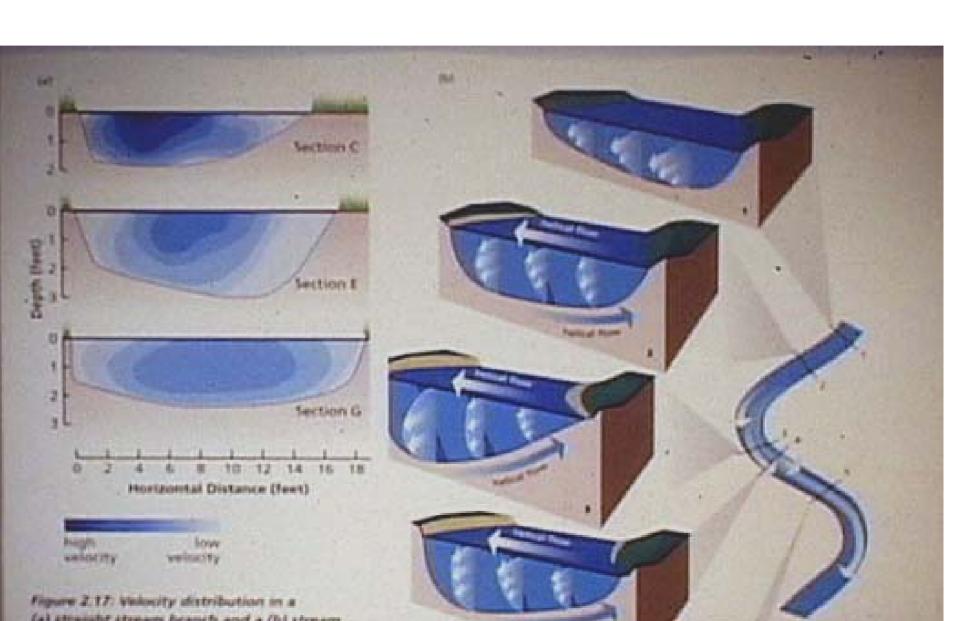
### Velocity vectors in meander

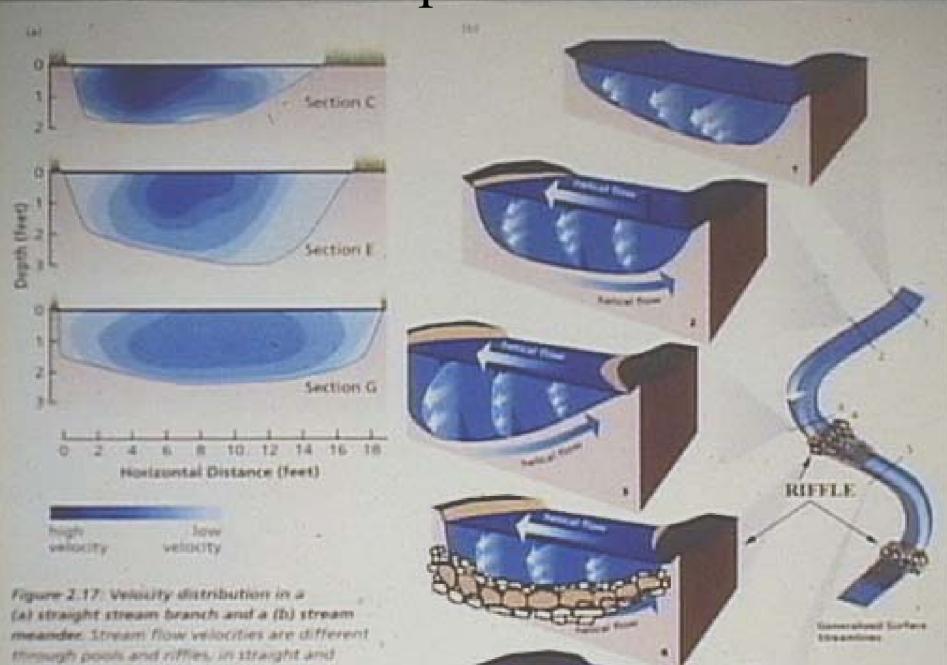
## Weirs placed in meander exits

Weirs breakup meander vectors

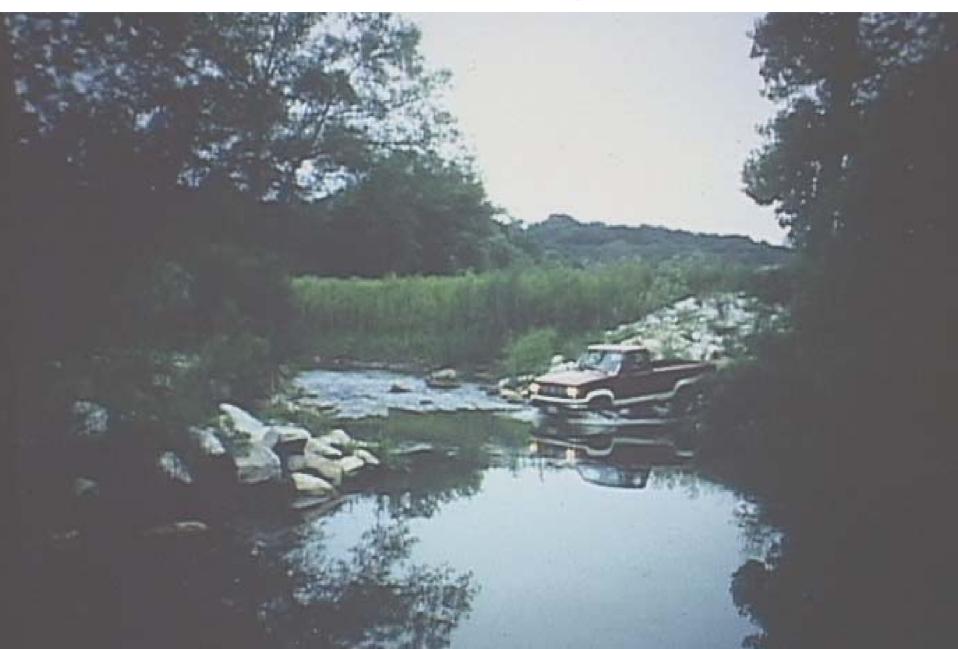
## Truck crossing weir

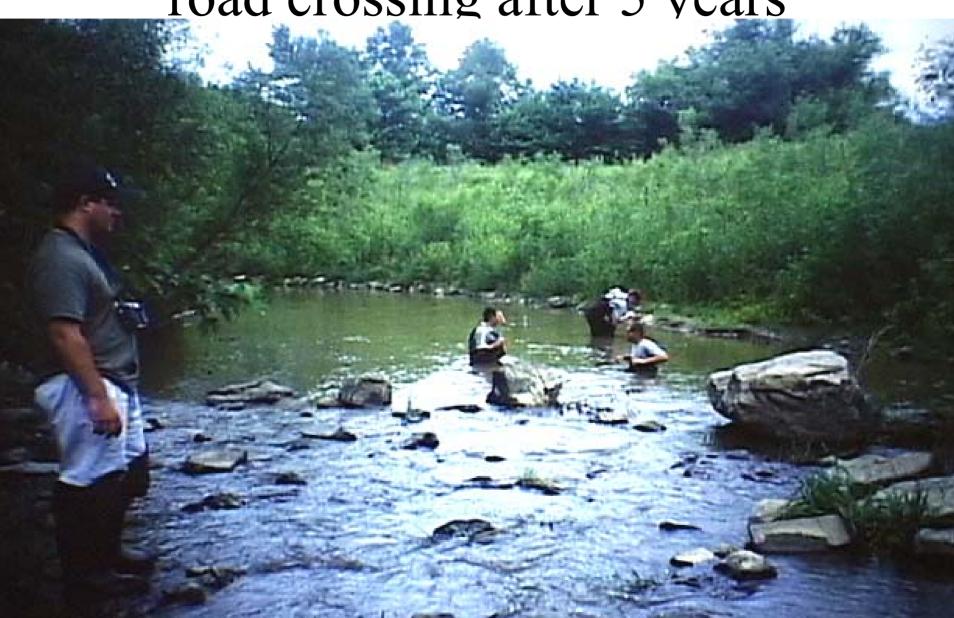
Pool depth and vegetation below road crossing after 5 years
